Open Door

Project location: Kulangsu, Xiamen, China

Designer: Beijing Guowenyan Cultural Heritage

Former Japanese Consulate in Kulangsu, Amoy, CHINA

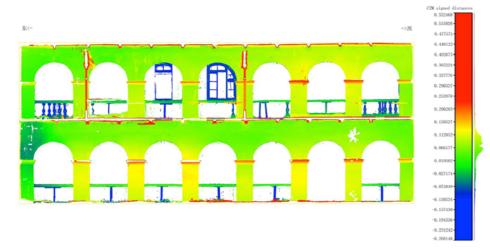
Analysis of the undulation of the south facade inside the building © CHCC

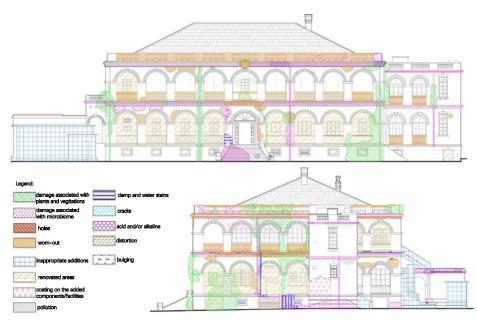
Analysis of the facade wall distress © CHCC

We reinforced walls of inadequate bearing capacity through "mortar replacement". We strengthened the walls in the southwest area, which was used more for service purposes historically. This way, we improved the building's overall anti-seismic performance with minimum intervention while ensuring safety. In terms of horizontal structural components, we reinforced the ceiling panels of Floor 1 and 2 with laminates. We removed two layers of bricks from the end connecting with the walls and added ring beams. We used carbon fiber sheet to strengthen the top of the moist insulation layer that was reinforced in the 1990s, and install sandwich beams at the bottom and one side of the interior walls.

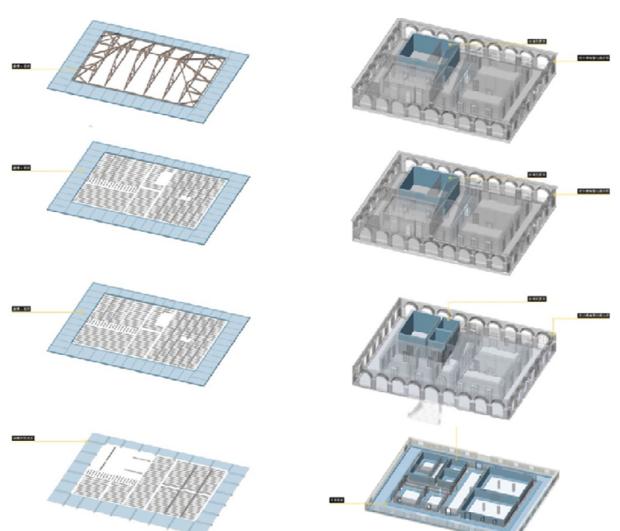
The area where structural reinforcement was performed with sandwich beams, wall panels and concrete laminates (the blue part) © CHCC

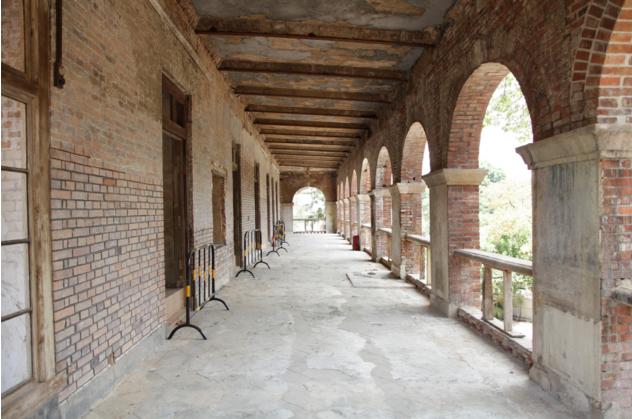
F/1 veranda under renovation © Zhang Guangwei

For the design of the veranda, an element of the typical characteristics, we balanced structural safety and the creation of a historical ambience. We reinforced the fair-faced brick walls through mortar replacement to continue the historical style. We strengthened the concrete slabs with laminates and restored the moldings strictly according to the historical style. After reinforcement, we added terrazzo flooring to the concrete floor to be consistent with the interior of neighboring buildings.

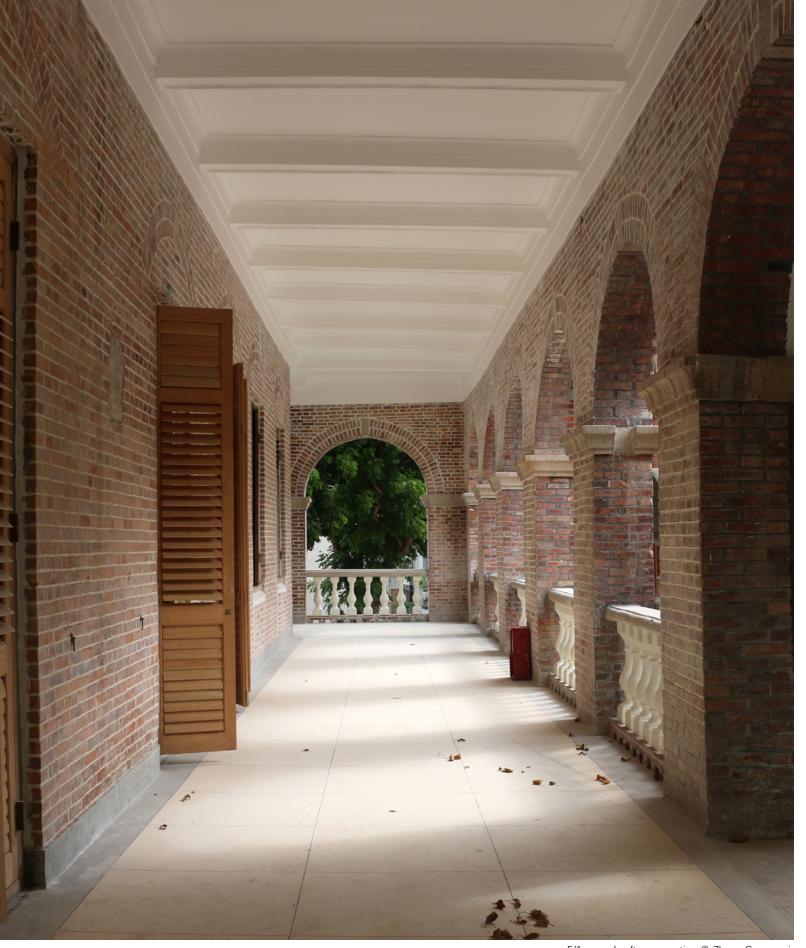
F/1 veranda after renovation © Zhang Guangwei

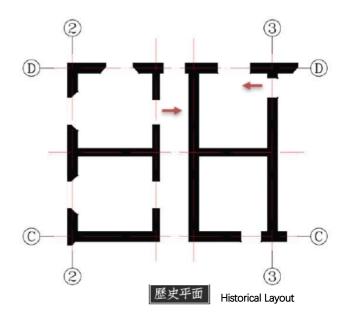
Room-blocking arches in the southwest area on Floor 1 © CHCC

When treating the traces of earlier renovations discovered

in the construction works, we selected the parts highly relevant to the historical drawings. We displayed them through structural reinforcement and construction instead of simply restoring them or covering the traces with plaster again.

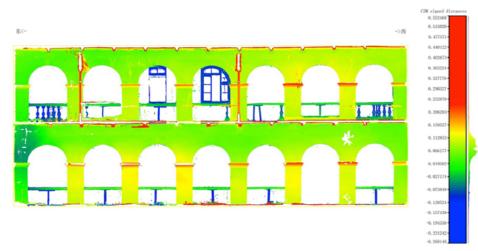
建筑内部南立面起伏分析图 ©CHCC

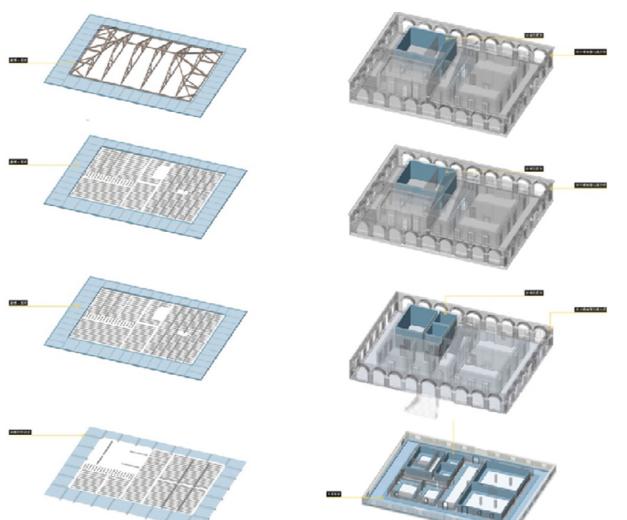
使用夹基梁、板墙和混凝土叠板进行结构加固的区域图示(蓝色部分)©CHCC

对承载力不足的墙体以"砂浆替换法"进行加固,选取历史 上使用功能偏服务性的西南房间区域进行板墙加固,提高 整体抗震性能,实现安全前提下的最小干预。水平构件方 面,一、二层顶板使用叠板法进行加固,入墙端去除两匹 砖以增设圈梁;对90年代做过加固的隔潮层顶板用碳纤 维布加强, 底板配合室内单侧板墙设置夹基梁。

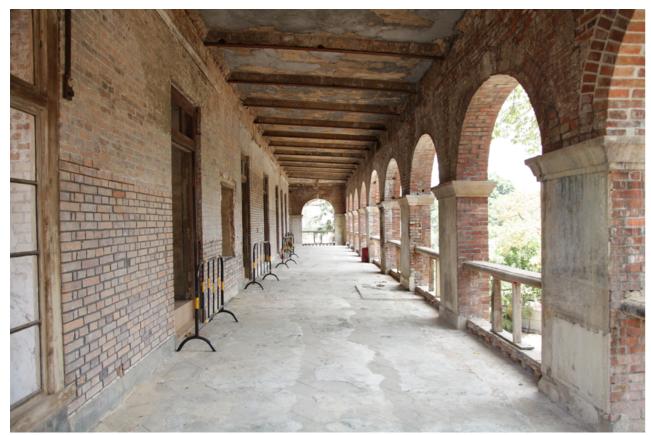
修复中的一层外廊 © 张光玮

对典型特征要素——环廊的设计,兼顾结构安全与历史氛围的营造,清水砖墙 以砂浆替换法加固、延续历史风貌,混凝土板以叠板法加固,并严格按照历史 样式恢复线脚、加固后砼楼面参照相邻建筑室内做法,增设水磨石铺地。

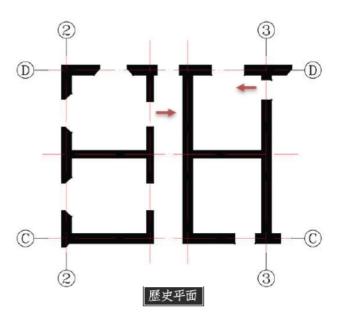
一层西南区房间封堵券洞 ©CHCC

施工中发现的墙体早期改造痕迹,选取局部与历史图纸相关较强的部分结合结构加固和构造做法外露展示,而不是贸然恢复或再次用抹灰掩盖。
