Call for proposal stream finalists  
案例征集入选者

# **An enlightening discovery: Renovation of Williams House on the campus of Nanjing University**

## **5. Conserving Williams' House as a heritage building**

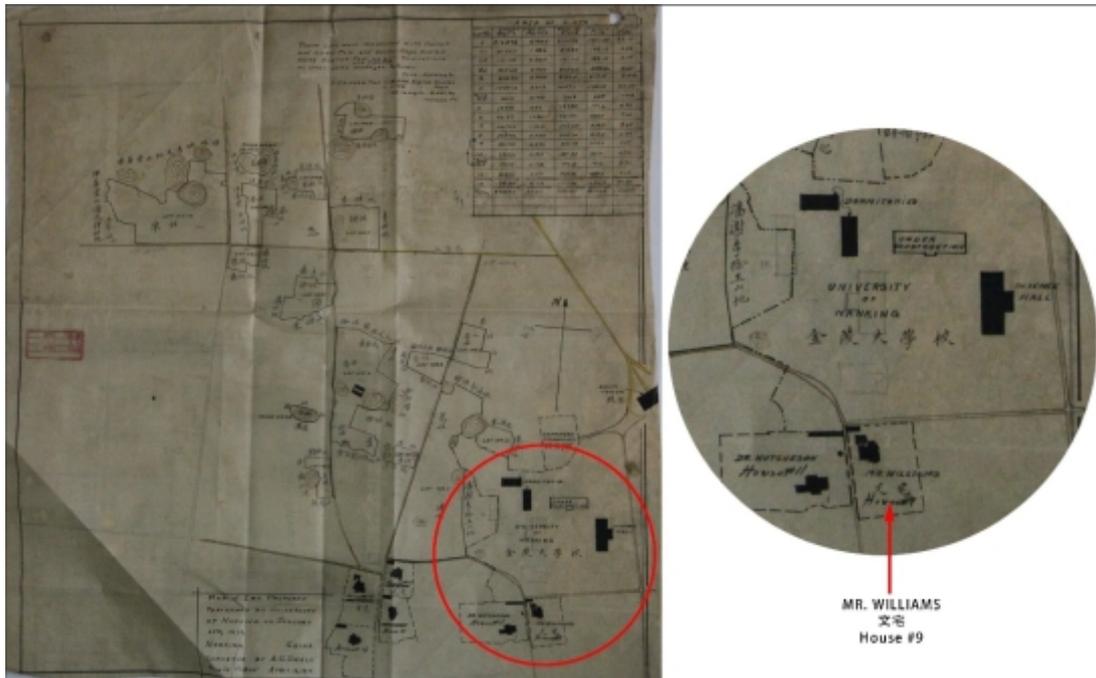
Figure 2 Map of Ing Property Purchased by UNK

These documents included UNK campus planning maps, which were sorted chronologically to determine when the residence had been built. The first map to show the profile of a 'new residence' fitting that of the residence is a 1911 site survey map. The house appears on every campus map since, and on the 'Map of Ing Property Purchased by UNK' in 1919 reproduced in Figure 2 the building is labelled 'Mr Williams House #9' ('文宅' in Chinese), providing a key piece of information. From this point onwards, the key figure who lived in the house emerged. This led to further questions to be solved in the next section:

这些文件包括金陵大学校园规划图，项目组队将地图按时间顺序排序，以确定住宅的建造时间。第一张显示“新住宅”轮廓的地图是一张 1911 年的校址勘测图。此后，这栋房子出现在每一张校园地图上，在图 2 展示的 1919 年金陵大学购置的 **ing** 房地产地图上，该建筑被标记为“Mr Williams House #9”（中文名标注为“文宅”），这提供了一个关键信息。自此，曾今居住在这栋房子里的关键人物出现了。这也引出了下一节中解决的问题：

图 2 金陵大学购置的 Ing 房地产地图

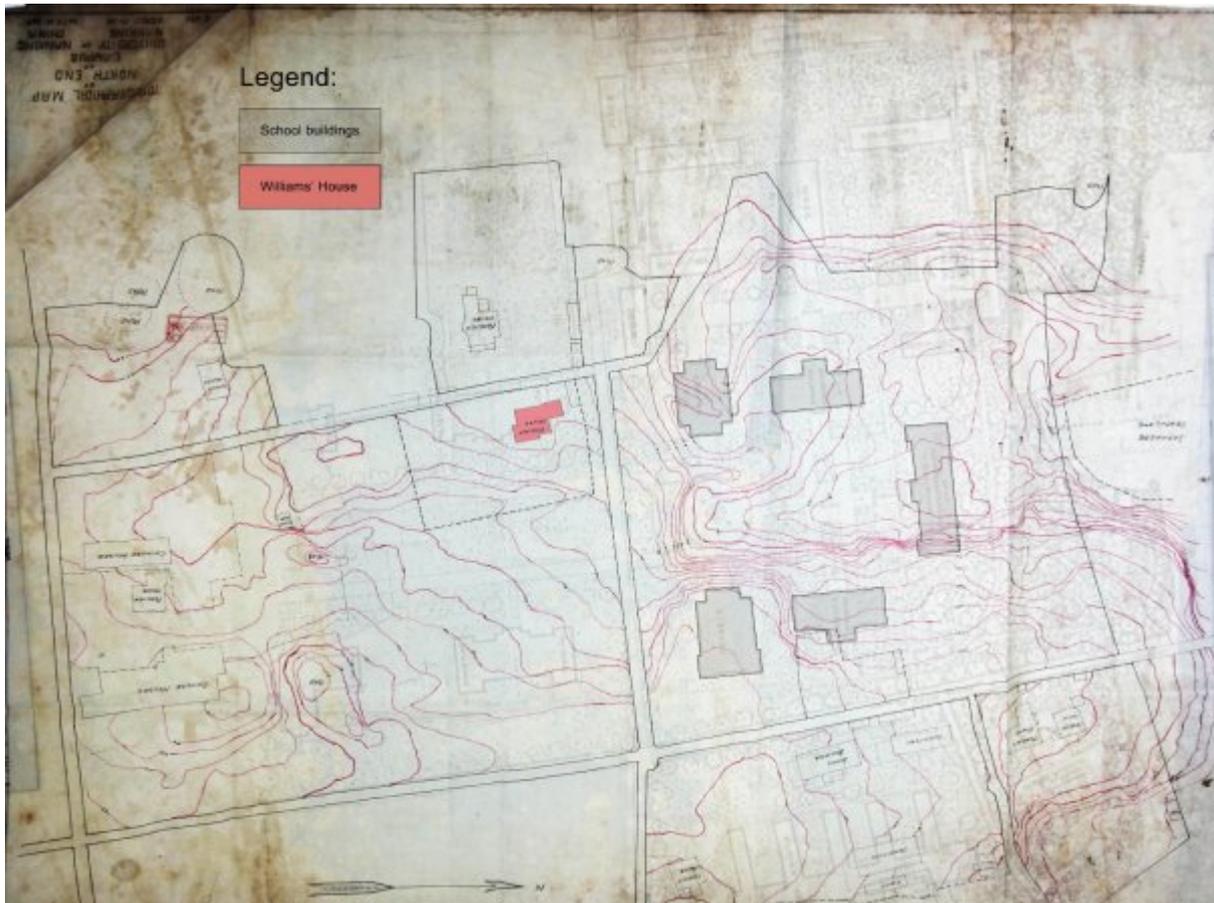
Figure 9 Topographical map of the campus (1914)

Among the collected materials, two photos taken from Williams' House show that the position of the house has a broad view over the future campus. Thus it is conceivable that the house was built as a watchtower to supervise the construction of the school buildings on the campus (Figure 8). In addition, a historic topographical map in 1914, overlaid with the campus plan (Figure 7) illustrates that Williams' House had been built before 1914 when the adjoining land for future construction of other school buildings was still a sloped vacant lot, which also supports the above assumption (Figure 9).

Source: Archive of Nanjing University (Volume 16, Campus planning 06); School buildings and Williams'

House were drawn and coloured by the author based on Figure 8

在搜集到的材料中，有两张从文宅拍摄的照片。照片显示，文宅有着开阔的视野，可以将未来的校区尽收眼底。因此可以推断，这栋房子是作为监督校园内学校建筑施工的瞭望塔而建造的（图8）。此外，将1914年的历史地形图与校园规划图相互叠合（图7）显示，文宅是在1914年之前落成的，当时旁边计划用于未来建造其他学校建筑的土地仍然是一块倾斜的空地，这也印证了上述假设（图9）。

图 9 校园地形图（1914）

来源：南京大学档案馆（第 16 卷，校园规划 06）；笔者根据图 8 绘制标记出了校园建筑和文宅的位置

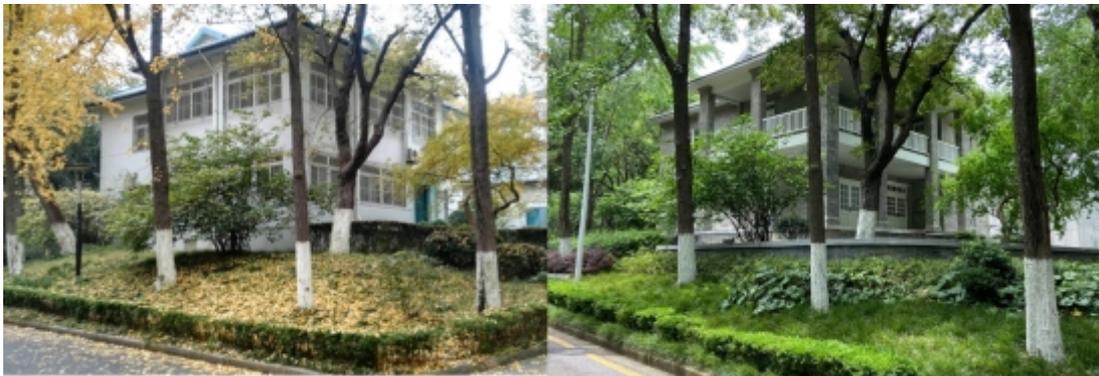
Figure 12 Before and after conservation

Before explaining our inspection and conservation strategy in the following sections, Figure 12 shows the appearance of Williams' House before and after conservation, which gives the reader a general impression of the result of the renovation. In the following sections, the survey and conservation scenario are introduced in five parts.

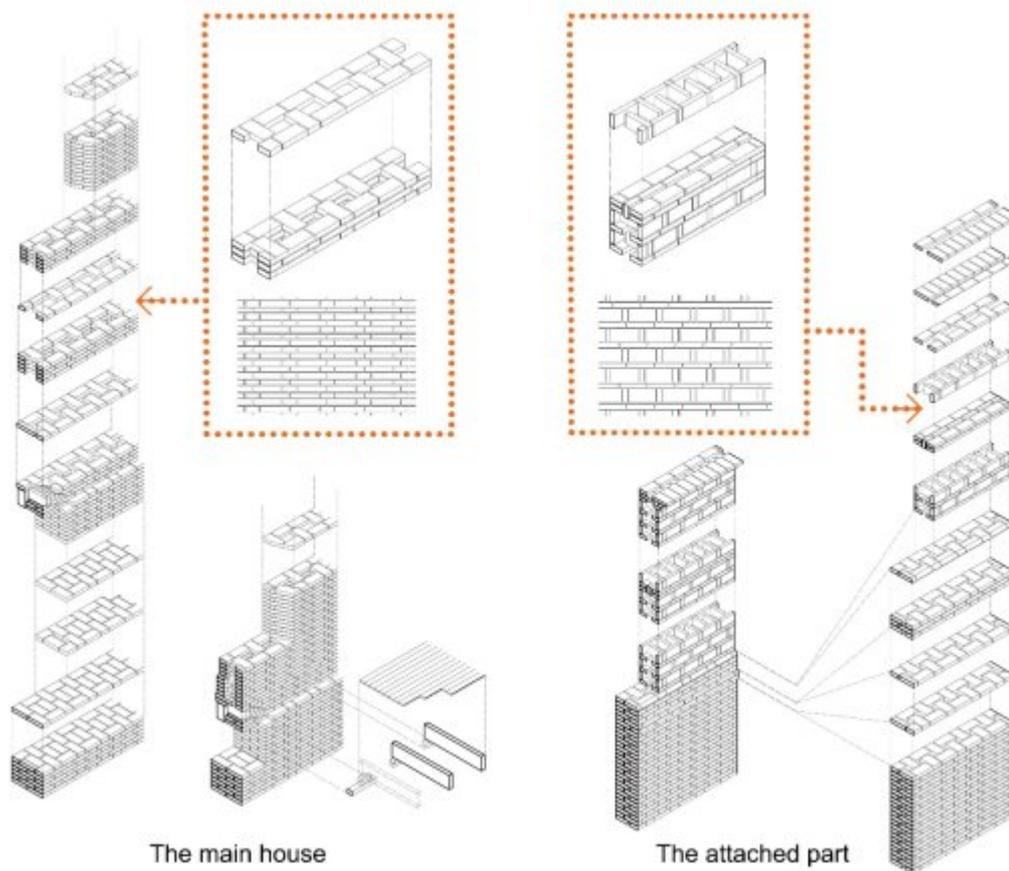
Figure 13 The construction of the brick walls of the main house and the attached part

As the building has been renovated several times by different departments, the layout has changed drastically. The interior space has been reorganised by the addition of new walls and the façade of the house, originally left with bare brick, has been covered by cement mortar. To repair a historic building, it is necessary to understand how it was constructed. To that end, the cement mortar was peeled off and additional external brick walls were dismantled, which blocked the sunporch, to reveal the original layout and external material for inspection. When inspecting the connection part between the main house and the attached part, we found it is obvious that the main house and the attached part were constructed in different types of masonry bonds were used in their exterior walls (Figure 13). No strong evidence has been found to explain why the house has two parts and uses different types of bonds in its brick

masonry. A possible hypothesis is that the difference reflects the innovation of craftspeople in saving on bricks and construction time. Despite the difference in exterior walls, the plinths in both the main house and the attached part are constructed with a strong bond type called ‘Flemish Bond’ to ensure the steadiness of the foundations.

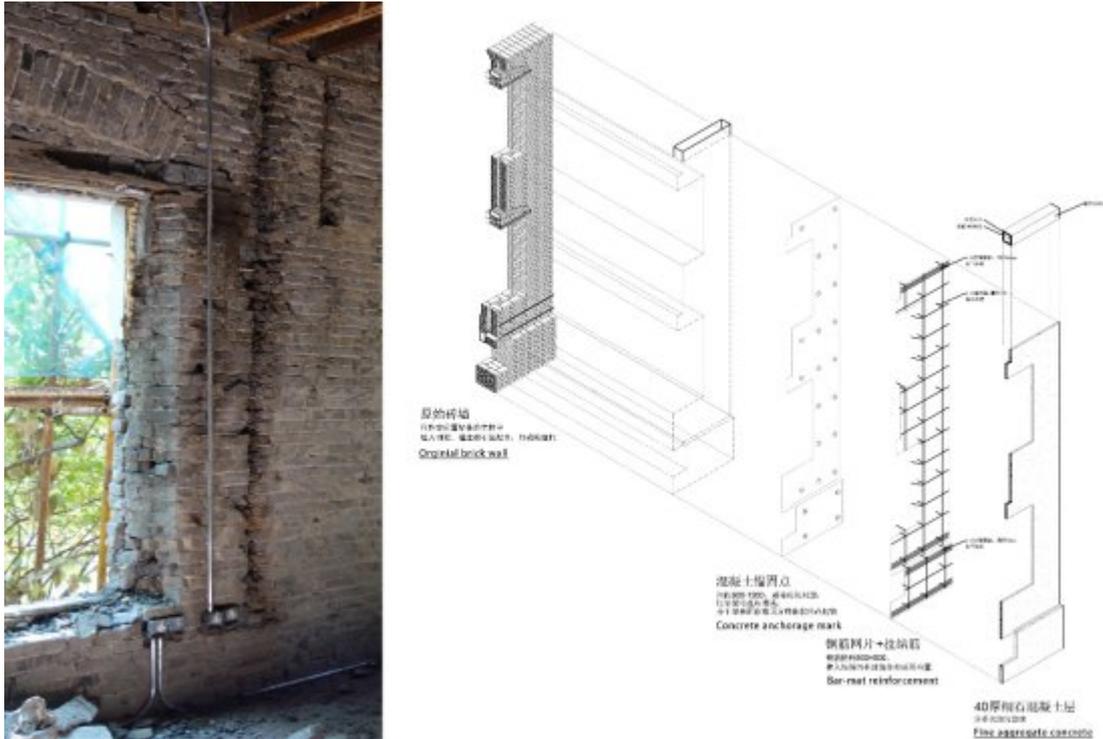
Figure 14 Reinforcement of the brick wall

During the survey, after the cement mortar was peeled off, the masonry structure of the building was looked vulnerable that many bricks of the house were destroyed and became rough and fragmented, which is structurally unqualified and needed reinforcement (Figure 14 left). To conserve the exterior brick wall façade of the building, bar-mat reinforcement was added on the inside of exterior walls (Figure 14 right).

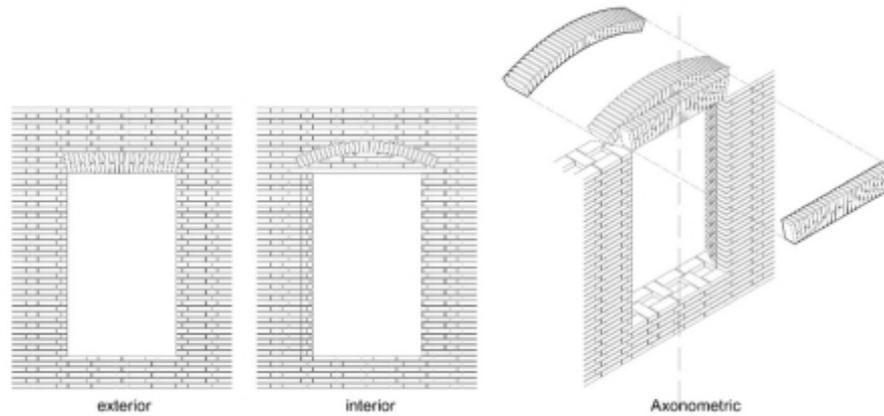
Figure 15 Research on the construction of openings in brick walls

Some of the openings in the exterior wall were blocked off and bricks around some openings were fragmented. Relying on our research on the construction of openings in brick walls (Figure 15), the openings were repaired according to vestigial evidence on the walls and the layout of the house. For example, fragmented bricks were replaced and the openings were recovered by adding flat arches<sup>8</sup> using the original construction method (Figure 16). Via this conservation approach, the original appearance of the walls has been recovered.

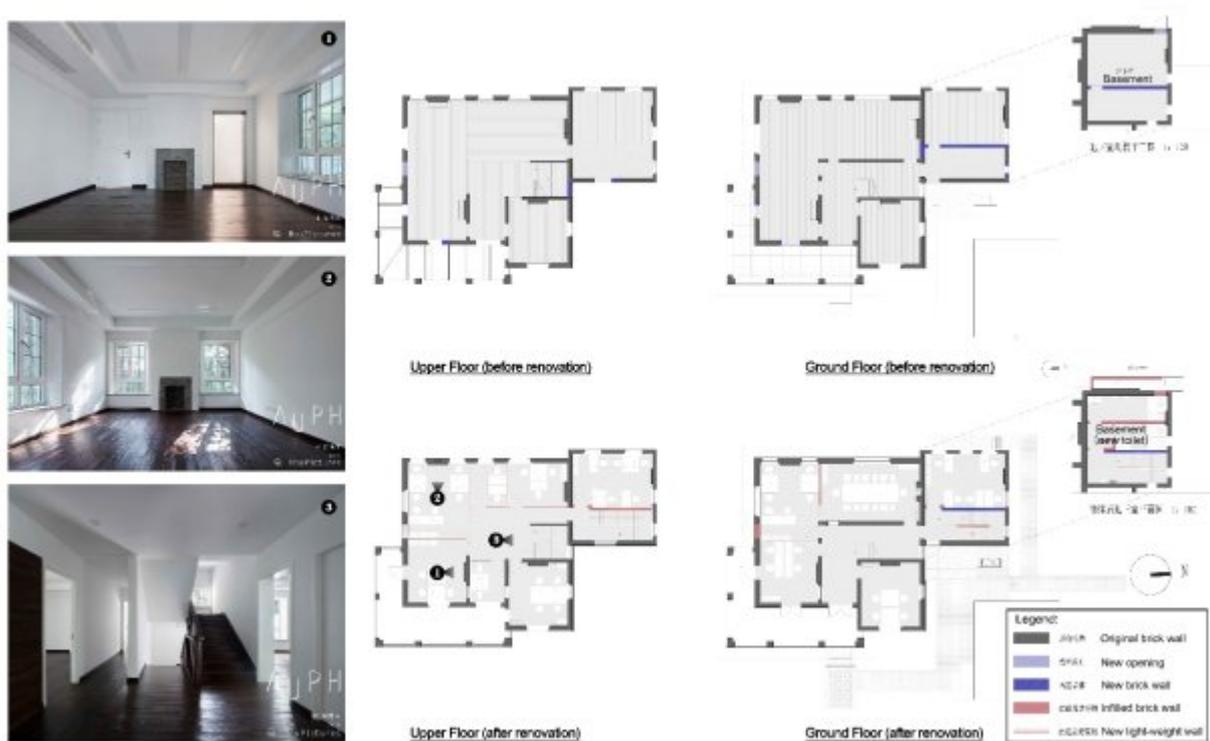
Figure 17 Floor plan of Williams’ House (before and after renovation)

that include these existing traces and other similar housing plans (e.g., the Bullock’s House and Pearl S Buck’s House) on campus. As mentioned in section 6.1, to meet the requirement of structural safety, the inner side of the exterior brick walls was reinforced. Both the inner side of the exterior walls and new lightweight partition walls were painted white for the brightness of the interior space. Since white plastering was found originally during the survey, the white coloured interior space balanced the historic value and use value. In addition, some original brick walls were conserved, especially the fireplaces, which act as the mark of its history and the typical indoor features of an American styled house built in Nanjing then.

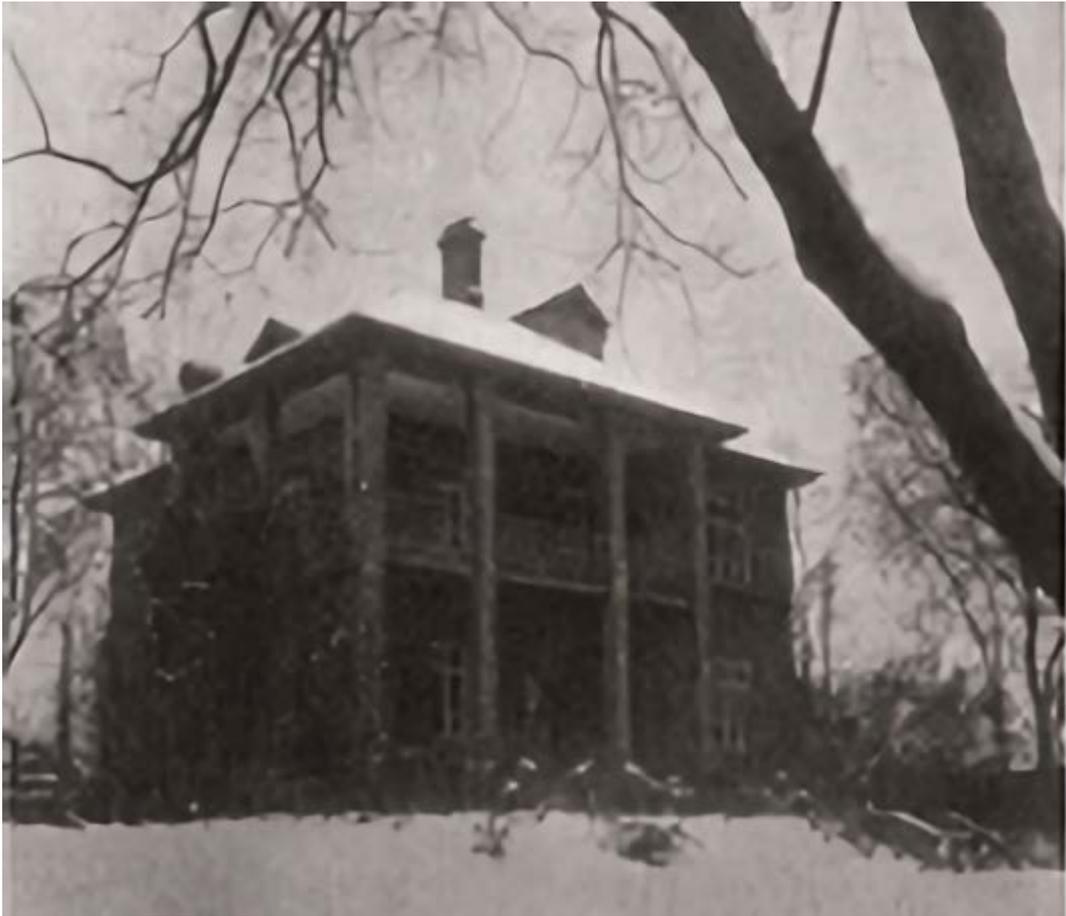
Figure 18 An unclear photo of Williams' House

These speculations were later proven by a historic photo of Williams' House taken from the southeast corner (Figure 18). Although the photo is of poor quality, it clearly shows the sunporch with white ceilings and handrails, as well as white windows and doors, which needed to be recovered.

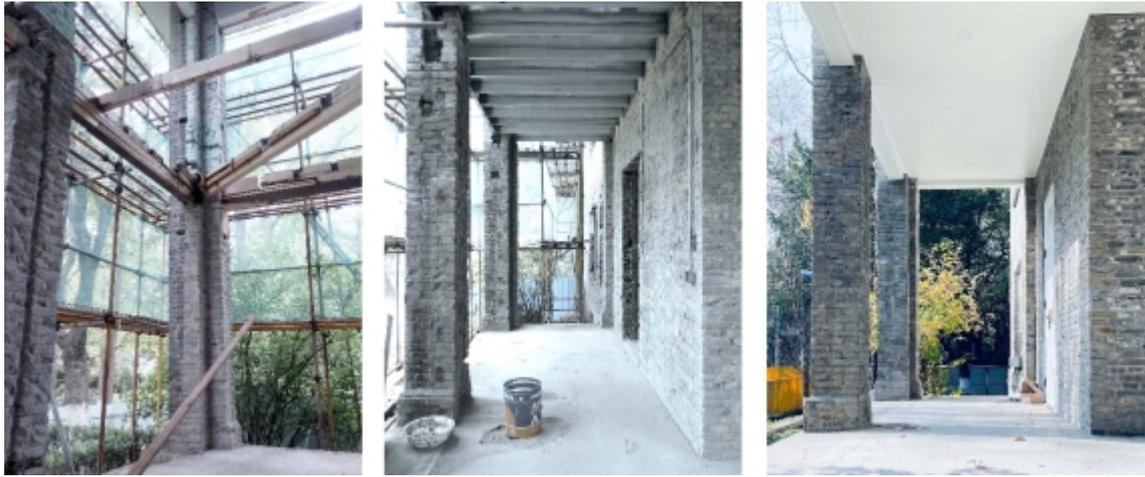
Figure 19 The sunporch repair process

As ceilings covered the structure of the sunporch, it was able to strengthen the structure with new materials and techniques rather than repairing the original beams, without compromising the appearance. To recover the sunporch and ensure its structural safety, steel and reinforced concrete were used to rebuild the floor with timber decking as the surface material. Although steel was not the original material used in the floor of the sunporch, it has better durability as it cannot be damaged by moths, and could be hidden by ceilings under the floor (Figure 19).

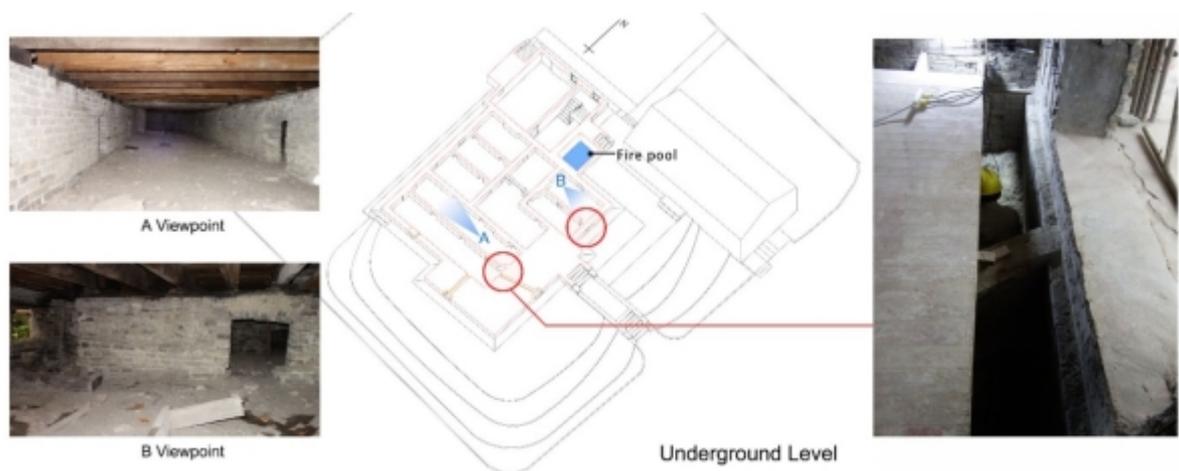
Figure 20 Underground level of Williams' House

To protect the house from moisture and humidity from underground, the interior was constructed with raised timber flooring and an underground ventilation system. In Williams' House, the underground level was constructed with brick sleeper walls to support the beams for the raised flooring. These sleeper walls divide the underground space into several zones, with openings between different zones reserved for ventilation. The underground space of the main house is divided into eight zones, including two long rectangular zones, five short rectangular zones and an L-shaped zone (Figure 20). Except for the latter, each zone has a venting interface on the exterior wall with a ventilation opening. The divisions of the underground level mean that humid air can be taken away, giving the timber flooring of the ground level more durability.

Given the height difference between the interior and exterior space, two platforms served as side entrances to the attached part of the house. To maximise the use of space under the east-side platform, a partially underground emergency fire pool was installed (Figure 20). Next to the fire pool under the attached part is an underground area located on the west side. Other than as a venting zone, this area is used as a storeroom, so underground venting zones are isolated between the main house and the attached part.

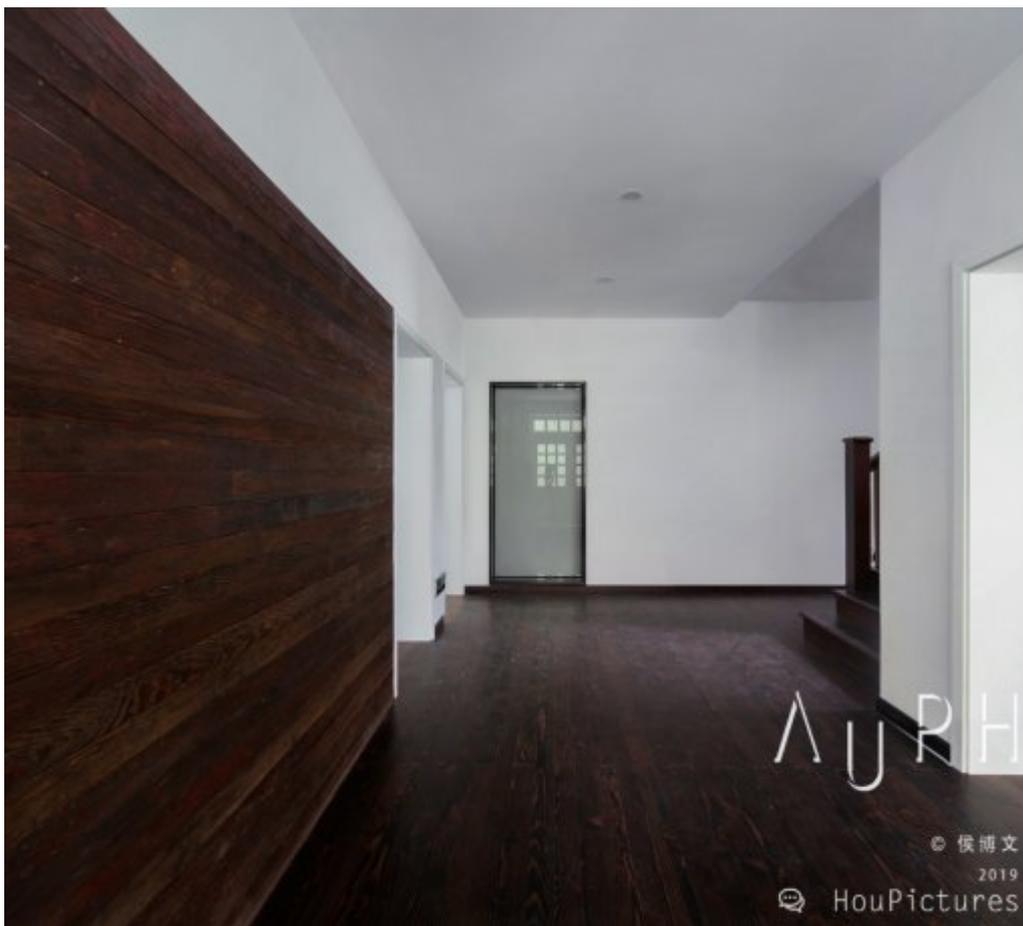
Figure 21 An interior wall covered by decking timbers disassembled from the ground floor

timber decking to the ground level should be reinstated to ensure material authenticity; however, as the original timber was scuffed and caused an uneven floor, the university administrator requested it should be replaced with newly qualified timber decking. To preserve the material authenticity and collective memory associated with the original decking timber, it was used as a memorial decoration to cover an interior wall for touching to feel the sense of time and place (Figure 21).

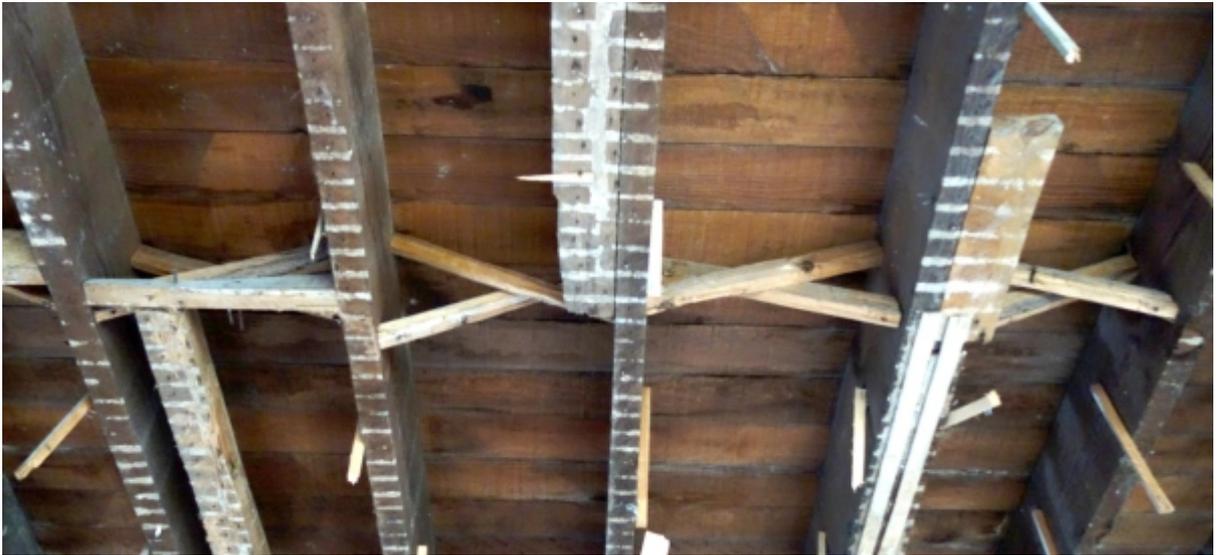
Figure 22 X-shaped timber connections between the timber joists

upper floor timbers was better than those of the ground floor, so the timber decking on the upper floor was preserved to ensure the material authenticity.

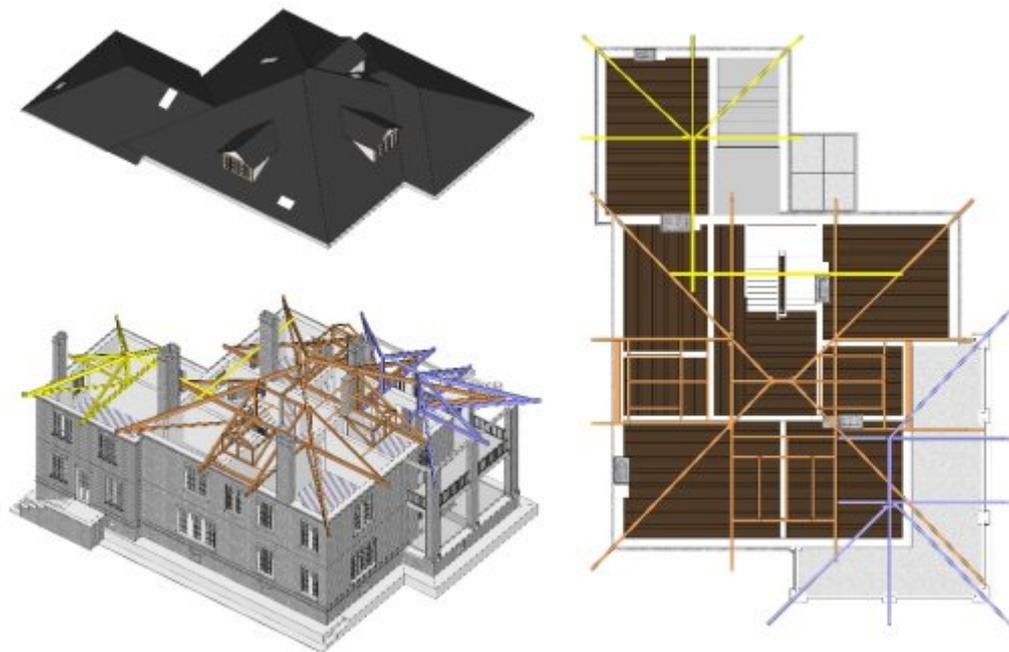
Figure 23 The digital model of the roof truss (top) and photo of the roof truss after renovation (bottom)

In terms of roof conservation, the loft space was renovated and the roof structure was intentionally exposed to show its value. Most of the roof boarding has been retained except for some leaking pieces, and insulation is planned to be added above the roof boarding to meet current requirements; although this process has been cancelled as a result of administrative issues.

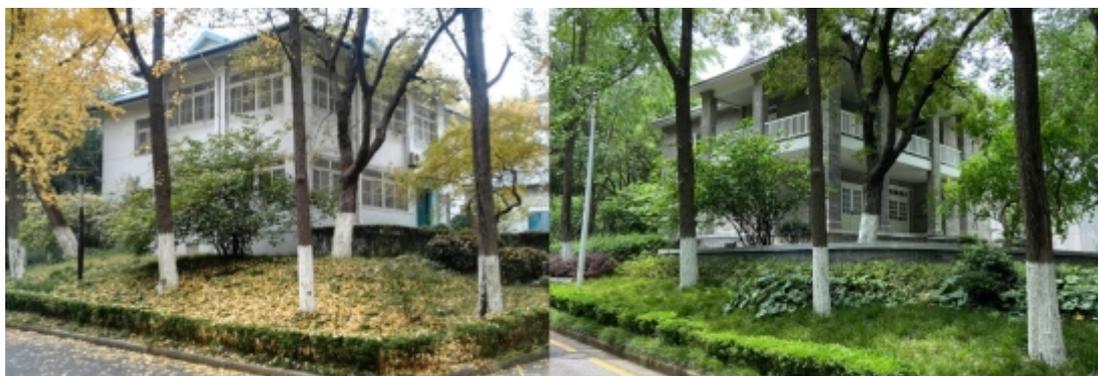
图 12 保护性修缮前后

在通过下文介绍团队的踏勘和保护策略之前，图 12 展示了文宅进行保护性修缮前后的外观，读者可以借此对改造的效果有一个大致印象。在下面的章节中，笔者将分五个部分介绍踏勘和保护工作。

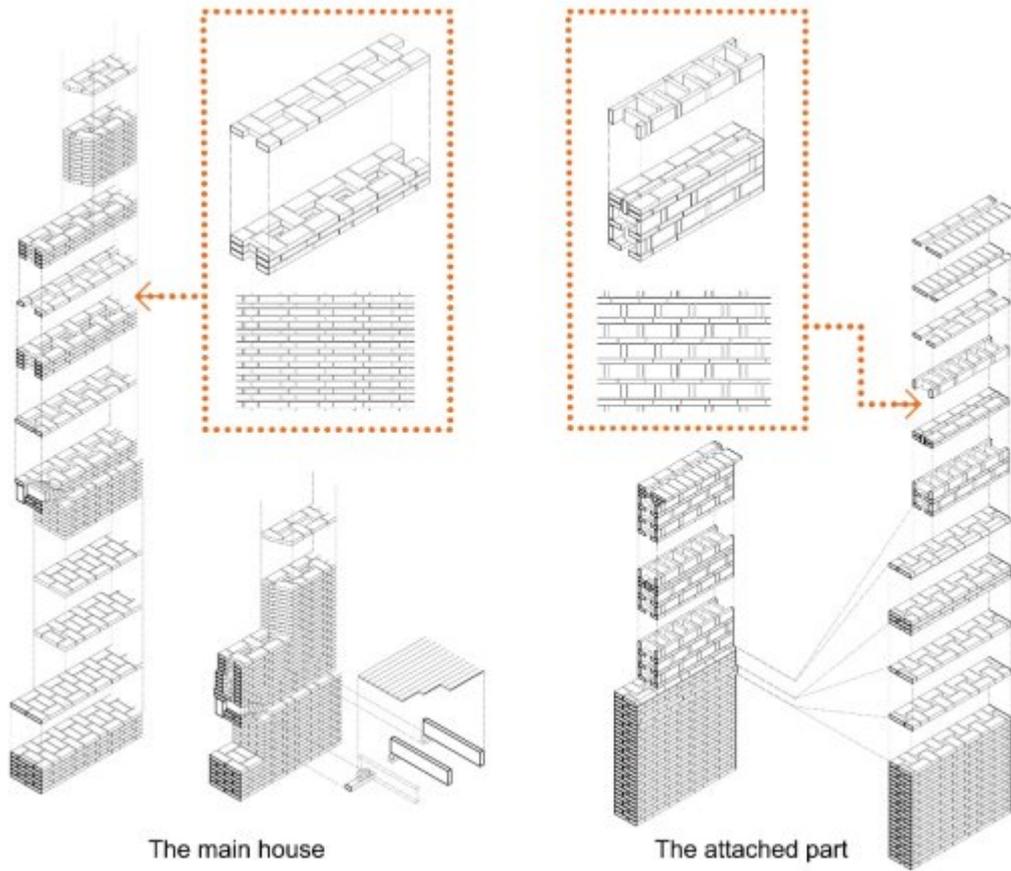
图 13 主屋和附房的砖墙砌筑方式

由于该建筑被多个部门进行了多次翻修，建筑布局发生了巨大的变化。内部空间被增建墙体重新划分，清水砖砌外墙被涂抹上了厚厚的水泥砂浆。要修复一座历史建筑，就需要了解它是如何建成的。为此，项目团队剥去了水泥砂浆，拆除了后来加建的封闭阳光敞廊的外部砖墙，恢复原始布局，露出原始的外部材料，随后进行踏勘。在检查主屋和附房的连接部分时，我们发现，主屋和附房的外墙明显采用了不同的砌筑方式（图 13）。目前还没有找到有力的证据来解释为什么该建筑由两个部分组成，并且还使用了不同的砌筑方式。一种猜测是，这种差异反映了工匠们在节省砖块和施工时间方面的创新。尽管外墙不同，但主屋和附房的柱基都是用一种叫做荷兰式砌合

法（Flemish Bond）的坚固砌筑法建造而成，以确保地基的稳固性。

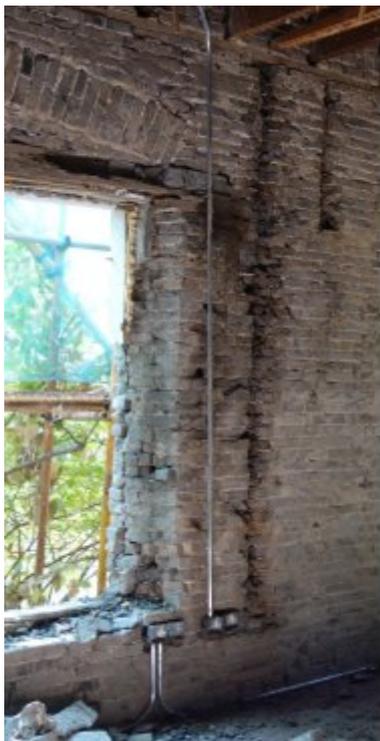
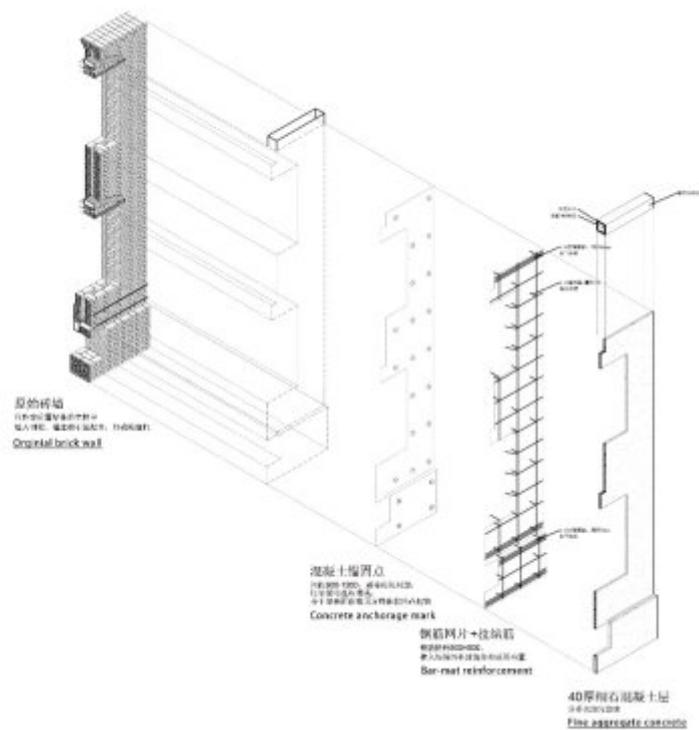
图 14 砖墙加固

踏勘过程中，水泥砂浆被剥落后，建筑的砌体结构显得很脆弱，房屋多处砖块损坏，变得粗糙破碎，结构上不稳固，需要加固（图 14 左）。为了保护建筑外墙的清水砖面，在外墙内部植入了钢筋网片和拉结筋进行加固（图 14 右）。

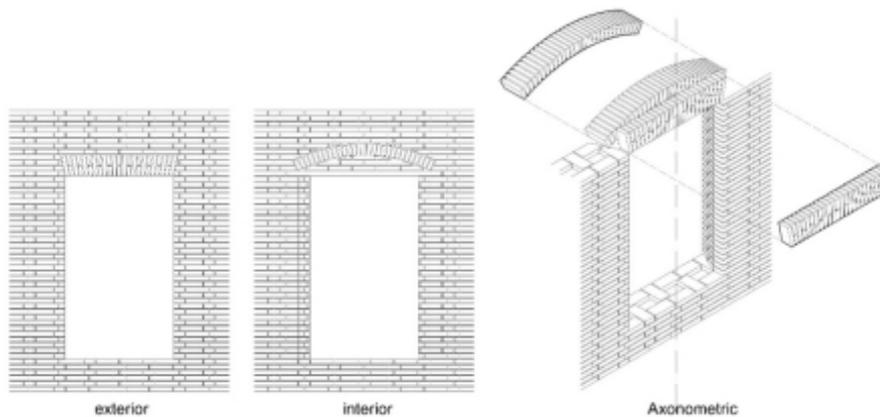
图 15 对砖墙开洞建造方式的研究

外墙的一些原始开洞被封堵了，洞口周围有部分碎砖。基于我们对砖墙开洞建造方式的研究（图 15），我们根据墙壁上的残余的痕迹和房屋原始布局对开洞进行了修复。例如，更换碎砖，并采用原始施工工艺增加平拱过梁<sup>8</sup>，恢复门窗开洞（图 16）。通过上述保护性修缮，恢复了墙壁原貌。

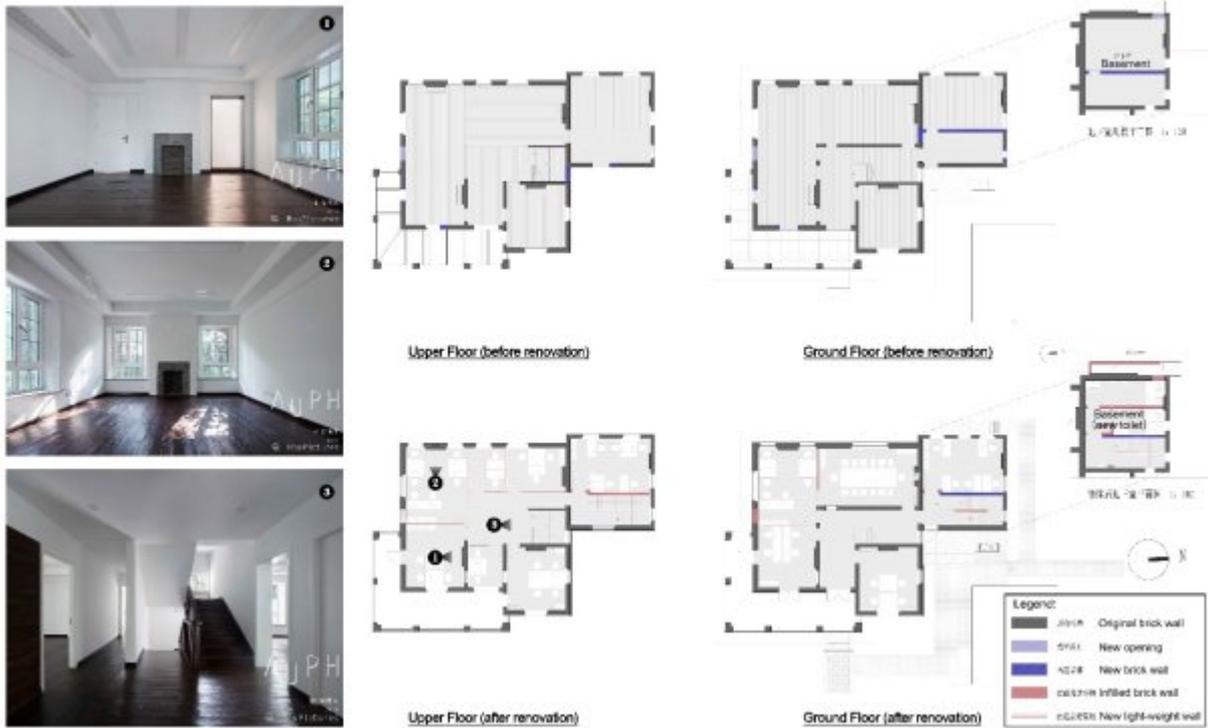
图 17 文宅平面图（修缮前和修缮后）

为了平衡其历史价值和使用价值，项目团队基于建筑踏勘绘制了当前的一层和二层平面图，并设计了能够最大限度地恢复新文宅原始布局的新平面图（图 17）。剥离水泥砂浆后，能够看到一些指明房屋隔墙原始位置的痕迹。根据这些证据，包括现存的痕迹和校园内其他类似房屋的平面图（如布洛克住宅和赛珍珠故居），新增了轻质隔墙。如 5.1 节所述，为了满足结构安全的要求，对外砖墙的内部进行了加固。外墙内侧和新增的轻质隔墙都被涂成白色，以增加室内空间的亮度。由于在调查过程中发现了白色的抹灰，将室内空间涂成白色平衡了历史价值和使用价值。此外，一些原始的砖墙被保留下来，特别是壁炉，他们是历史的象征，也是当时南京美式风格房屋的典型室内特征。

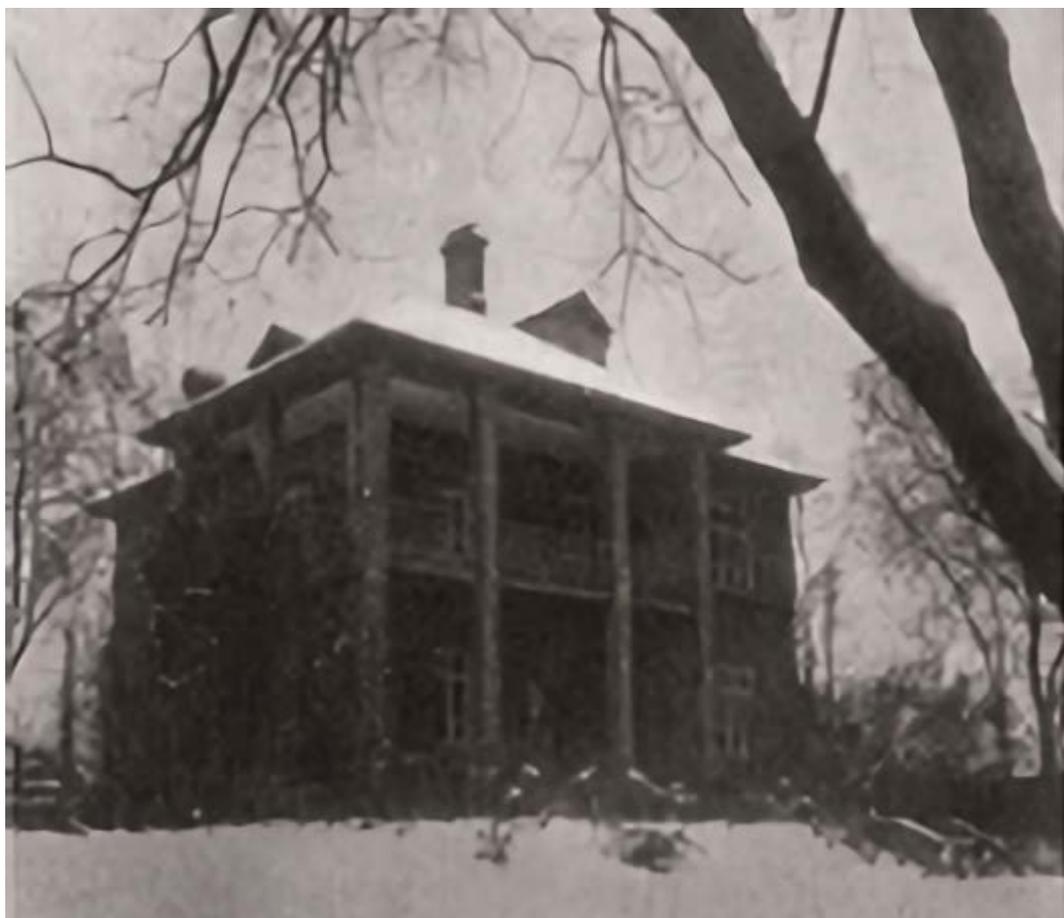
图 18 一张模糊的文宅照片

这些猜测后来被一张从东南角拍摄的文宅照片所证实（图 18）。虽然照片的画质不佳，但它清楚地显示了带有白色天花板和围栏的阳光敞廊，以及需要恢复的白色门窗。

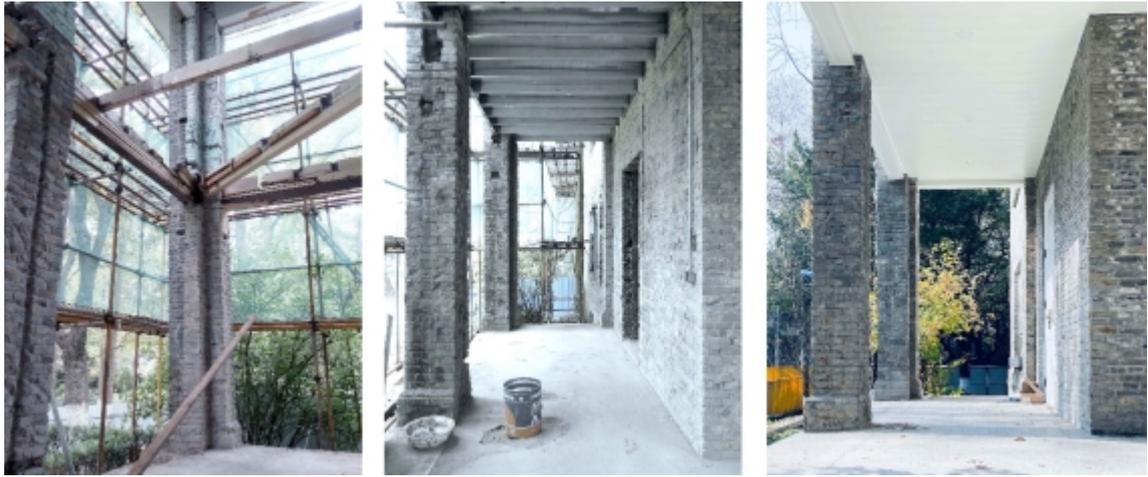
图 19 阳光敞廊的修缮过程

由于阳光敞廊上方设置了吊顶，所以即便不修缮原始的横梁，也能够在不影响建筑外观的同时，通过运用新材料和新技术对结构进行加固。为了恢复阳光敞廊并确保其结构安全，项目团队使用了钢筋混凝土来重建楼板，在此之上再覆上木铺板。虽然原始阳光敞廊的楼板中并未使用钢材，但钢材不会受蛀虫危害，因而具有更好的耐久性，且可以隐蔽于楼板下方的吊顶内（图 19）。

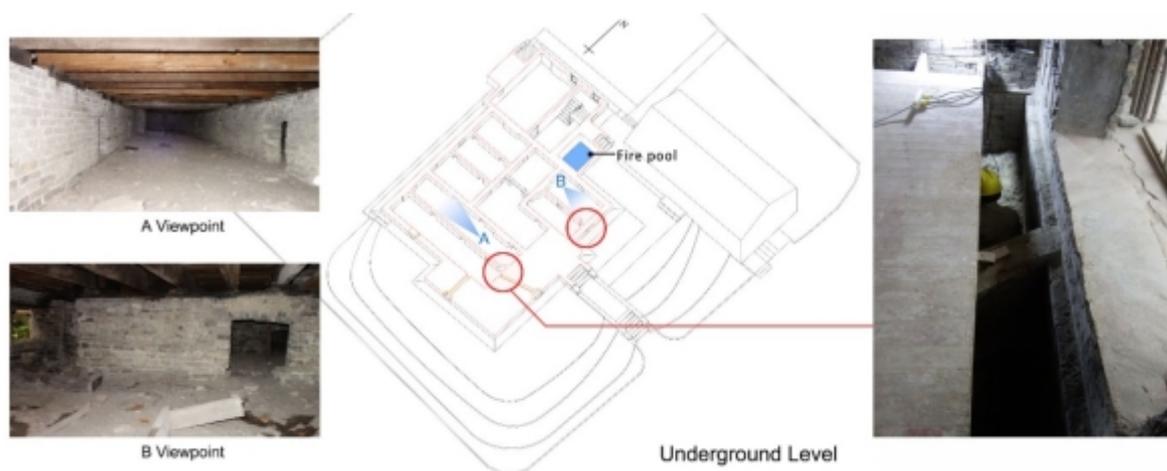
图 20 文宅的地下空间

（图 20）。附房下方消防池旁边就是西翼的地下区域。这块区域除了用作通风区域外，还兼具储藏功能，这样地下通风区域就将主屋和附房隔离了开来。

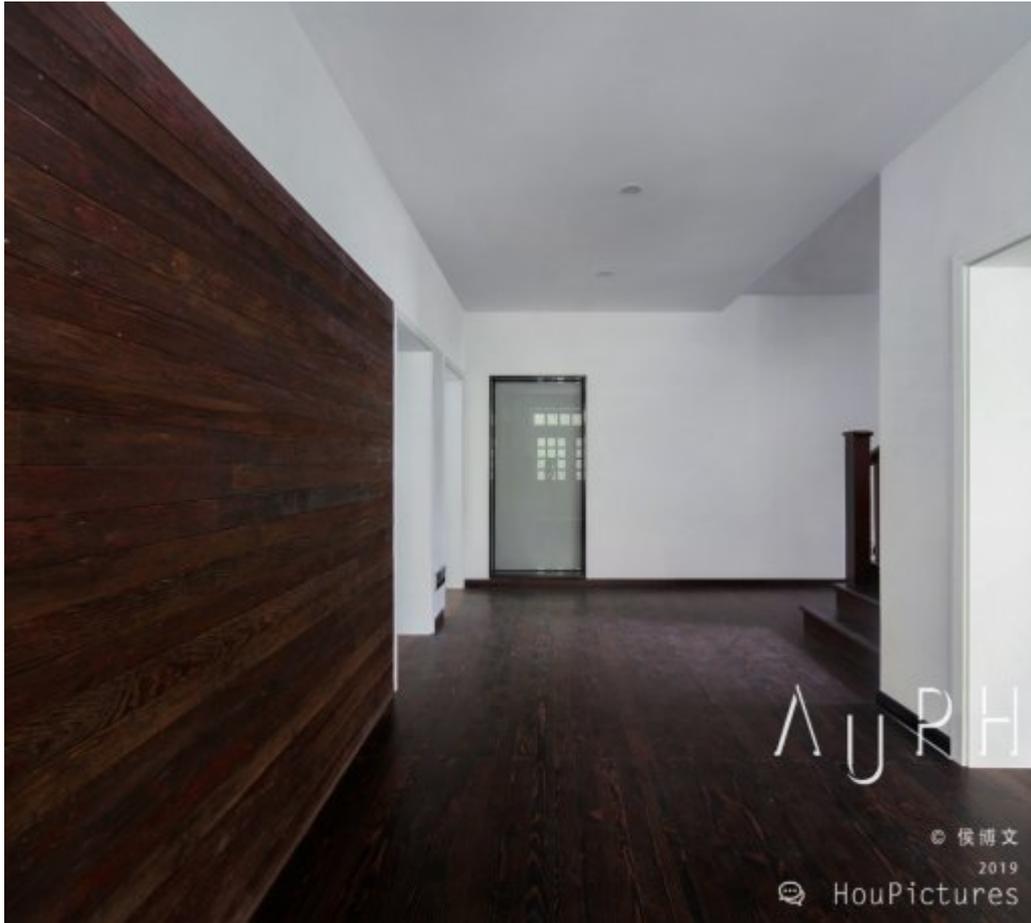
图 21 一楼拆除的木质铺板材料被铺装在一面内墙上

如第 5.3 节所述，项目团队拆除了建筑一层的木铺板，对地基进行了加固。完成这步操作之后，为了保护建筑的遗产价值，应该恢复一层的木铺板，以确保材料的真实性；但是，原始木材有所磨损，导致楼板不平，因此学校管理方要求使用新的合格木铺板来代替。为了保持材料的真实性并保留与原始木铺板相关的集体记忆，原始板材被用作纪念性的装饰，铺设在一面内墙上，让人们可以通过触摸原始板材感受到它所蕴含的年代感和场所感（图 21）。

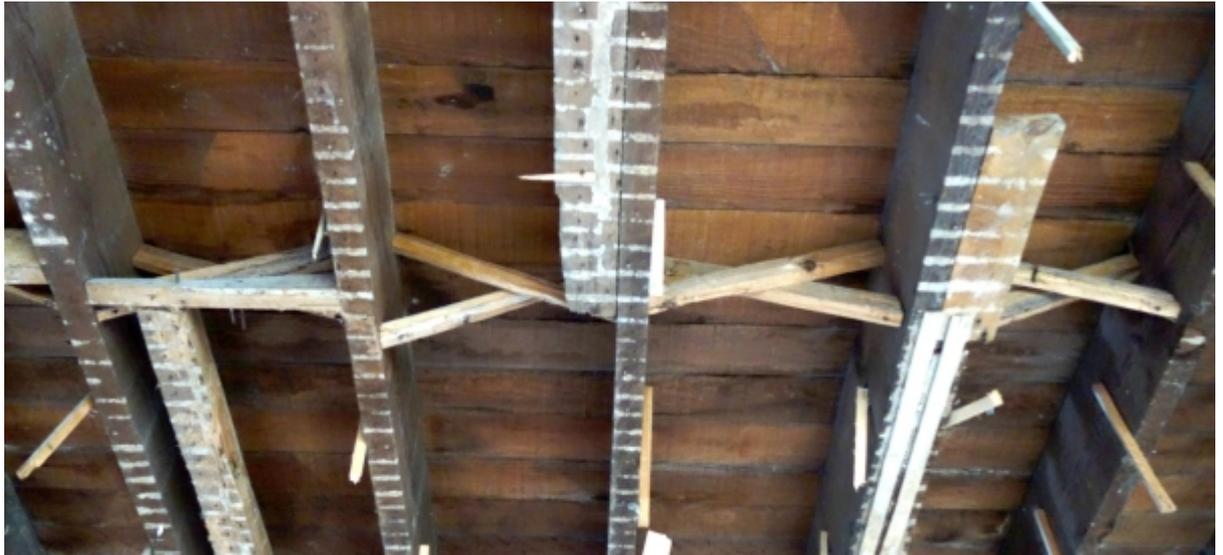
图 22 木梁之间的 X 形的木材连接件

二层的楼板方面，拆除顶棚后，可以清楚地看到，木梁两端都被固定在墙内，以承托二层楼板的重量。此外，楼板下方木梁间隔处有 X 形的木材连接件，以确保其结构的完整性和稳定性（图 22）。二层的楼板木材质量优于一层，所以选择保留了二层木铺板，以确保材料的真实性。

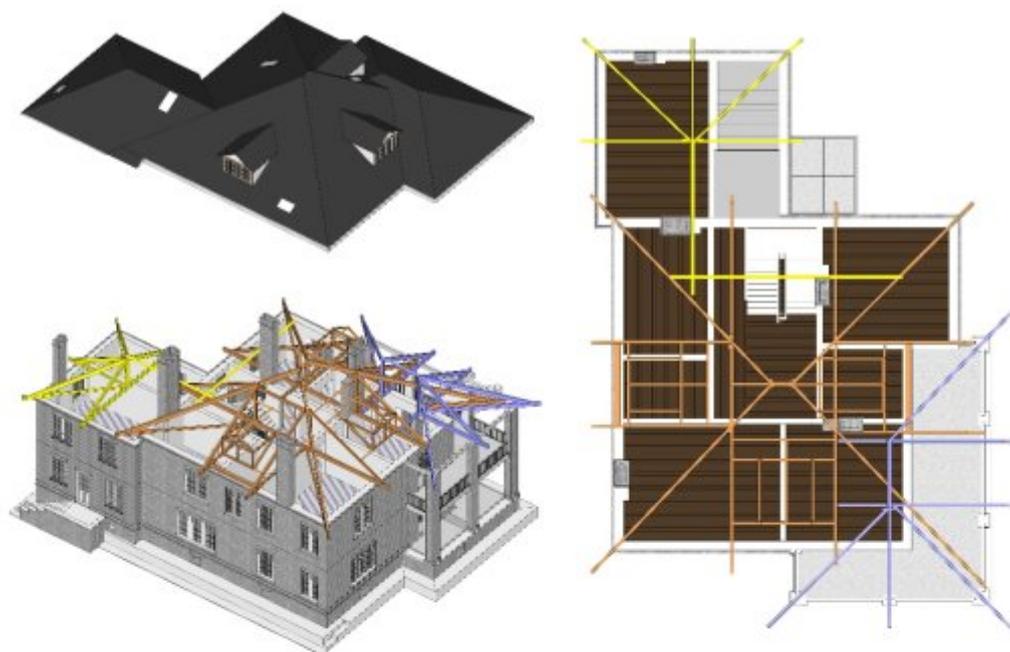
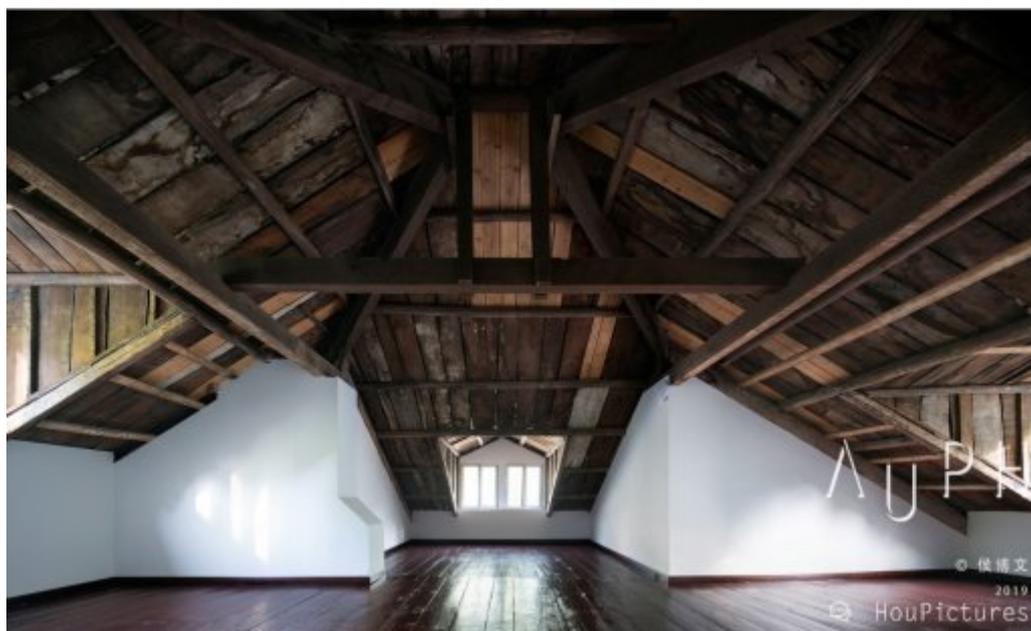
图 23 屋架的数字模型（上）和改造后的屋架的照片（下）

屋顶保护方面，团队翻新了阁楼空间，特意将屋顶结构暴露出来以展示其价值。除了漏水的板材，大部分的屋顶木板被保留了下来，还计划在屋顶木板上方增加保温隔热层，以满足当前的使用要求；不过由于行政问题，未能按计划增加保温隔热层。
