SUSTAINABLE PAST AND FUTURE GUIDE

81
GELHALTER
BROS LTD

November 2021

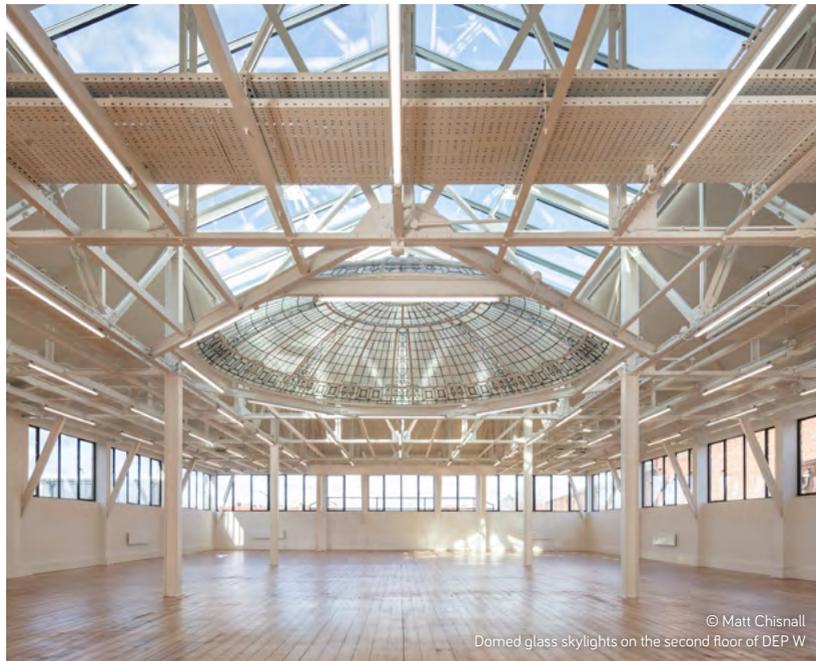
© Matt Chisnall
Domed glass skylights on the second floor of DEP W

The domed glass skylights on the second floor were repaired and restored, exposing the steel structure to create a

The existing and deteriorated structure meant that the original facade was badly in need of refurbishment. The original stonework facade has been repaired, removing pipework and other services that have been added over time. Repaired and restored domed glass skylight, while revealing the steel structure around this

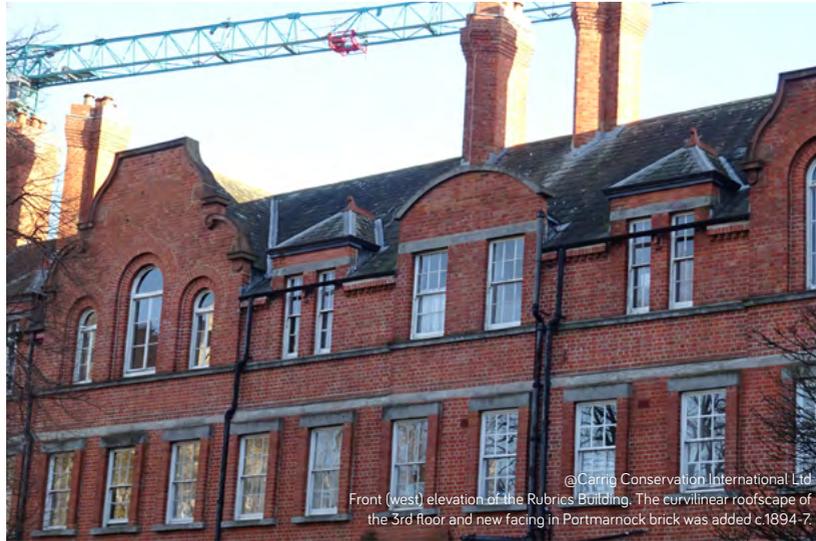
@Carrig Conservation International Ltd
Front (west) elevation of the Rubrics Building. The curvilinear roofscape of the 3rd floor and new facing in Portmarnock brick was added c.1894-7.

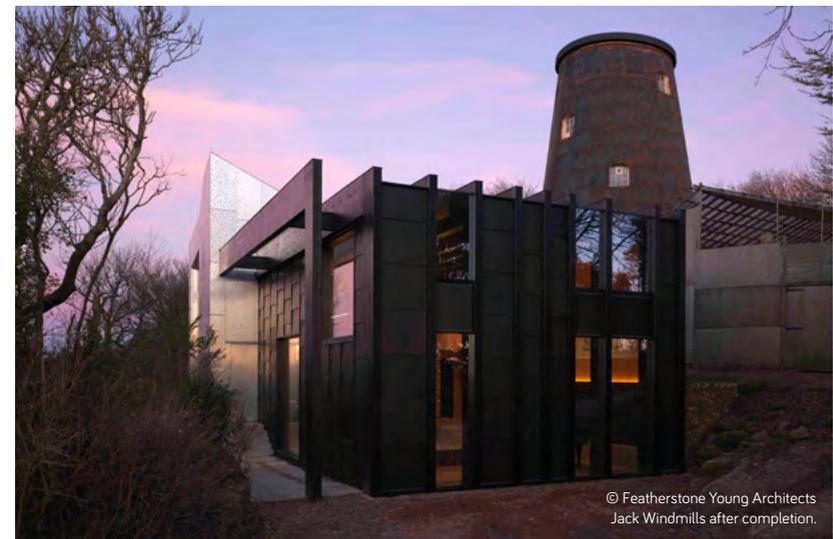
© Featherstone Young Architects
Jack Windmills after completion.

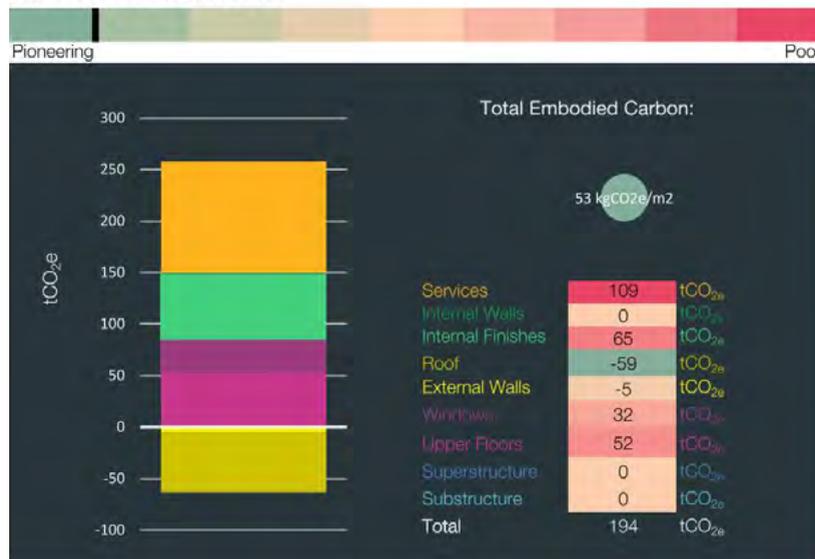
Sustainability stats for Shrewsbury Flaxmill Maltings produced by our FCBS carbon calculator tool.
 Embodied carbon 53 kgCO_{2e}/m²
 Operational energy use (regulated plus an assumption for unregulated) 91.47 kWh/m²/yr
 Re-using the existing building saved 80% of the carbon that would have been required for a new building.)
 FCBS

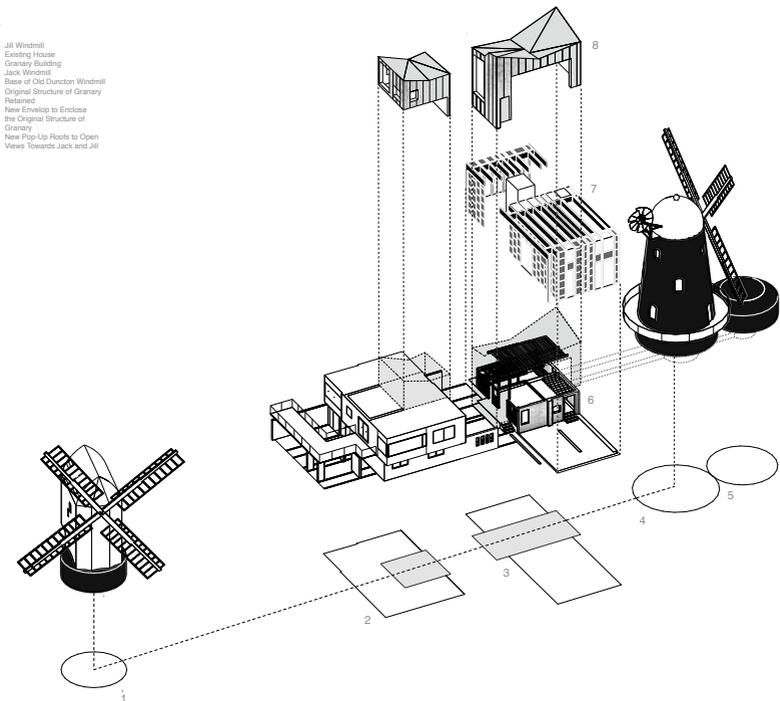
Proposed Axonometric © Featherstone Young Architects

KEY

- 1 Jill Windmill
- 2 Existing House
- 3 Granary Building
- 4 Jack Windmill
- 5 Base of Old Direction Windmill
- 6 Original Structure of Granary Retained
- 7 New Envelop to Enclose the Original Structure of Granary
- 8 New Pop-Up Roofs to Open Views Towards Jack and Jill

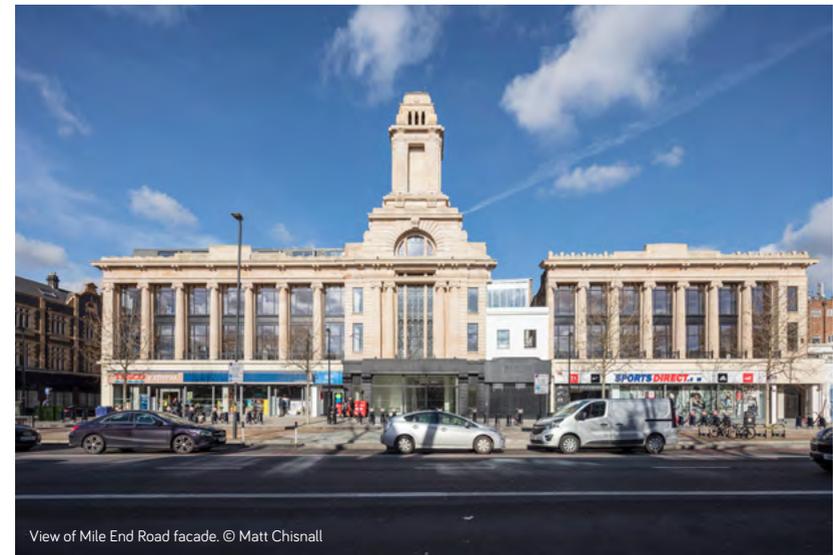
View of Mile End Road facade. © Matt Chisnall

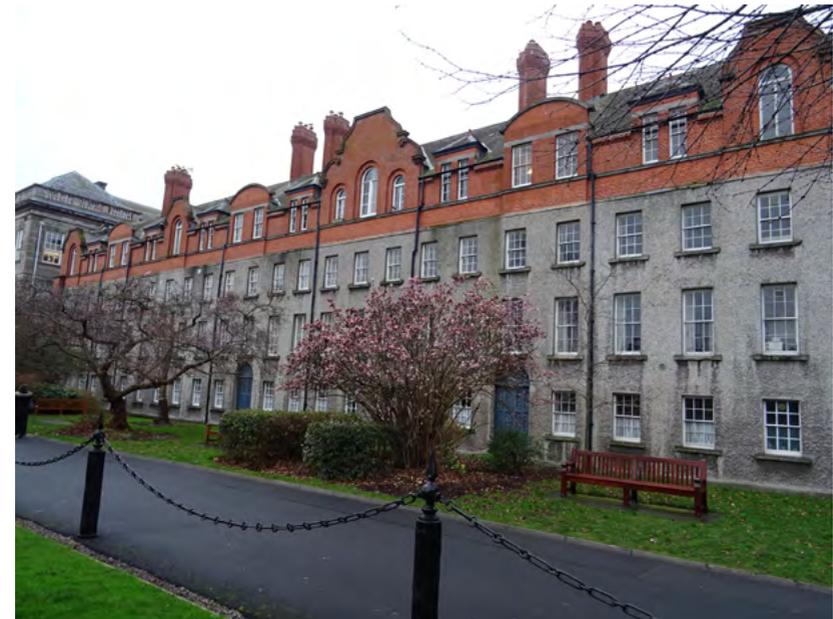
A contemporary view of the eastern elevation which shows how the building has changed over the years. The third floor was added in 1894-7 along with the present gabled arrangement. A coat of cement-based pebbledash was added to the elevation's Calp stone in the mid-20th century. © Carrig Conservation

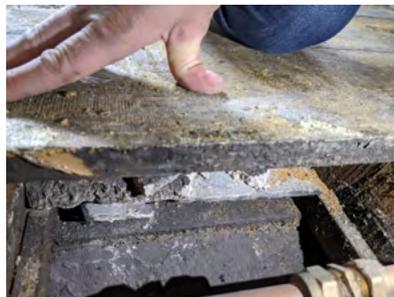
Historic slate covered with a lime and horsehair mix held in place by batten below the suspended timber floor. © Carrig Conservation

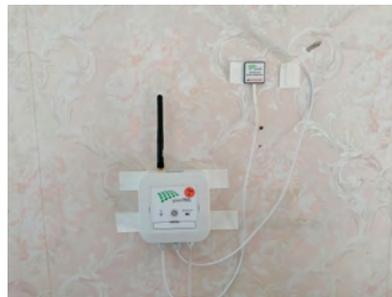
Internal GreenTEG in-situ u-value monitor installed in test apartment. © Carrig Conservation

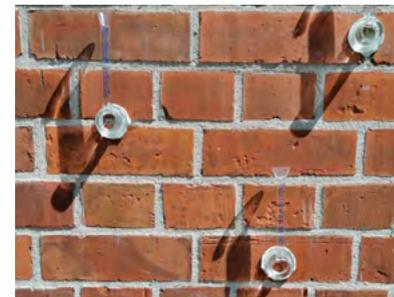
Karsten tube porosity tests underway on the historic brick of the Rubrics Building. © Carrig Conservation

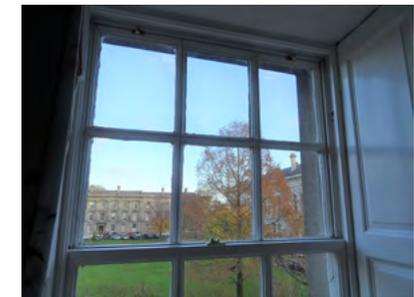
Early 18th-century sash window to the east elevation with thick glazing bars. © Carrig Conservation

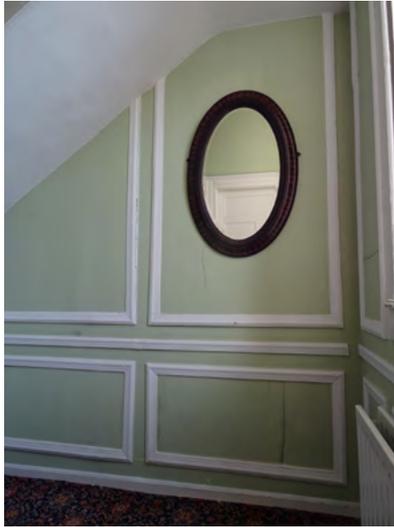
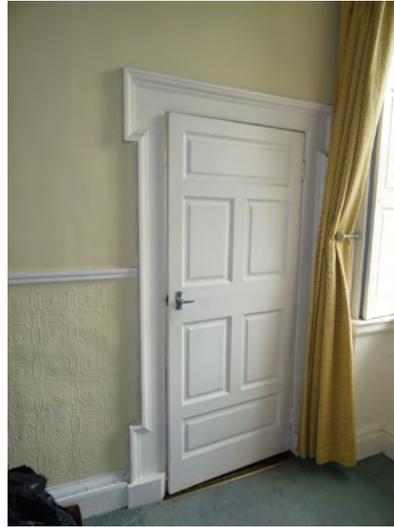
Original early 18th c. wall panelling in what would have originally been a two-storey apartment. Very little of the original panelling survives throughout the rest of the building.
© Carrig Conservation

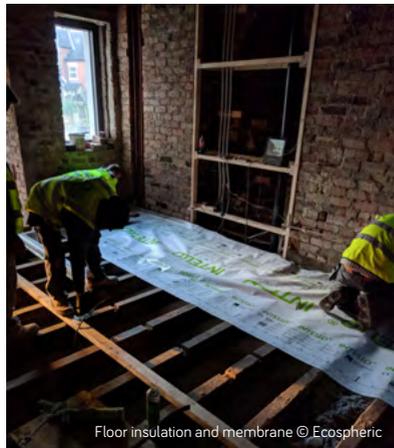
Floor insulation and membrane © Ecospheric

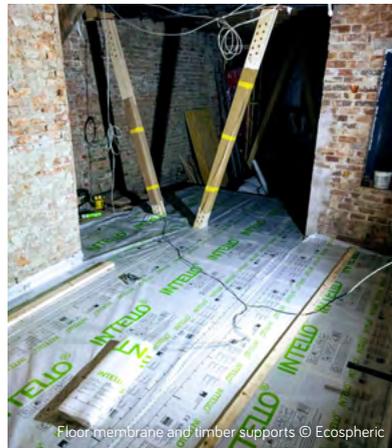
Floor membrane and timber supports © Ecospheric
