Open Door

Project location: Kulangsu, Xiamen, China

Designer: Beijing Guowenyan Cultural Heritage

Former Japanese Consulate in Kulangsu, Amoy, CHINA

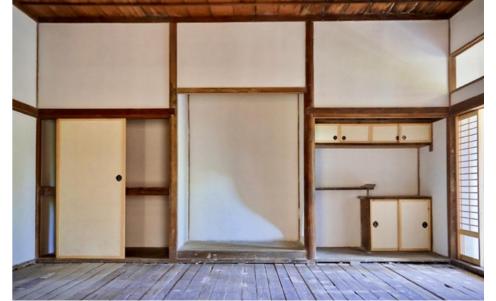
和室床间 © 魏青

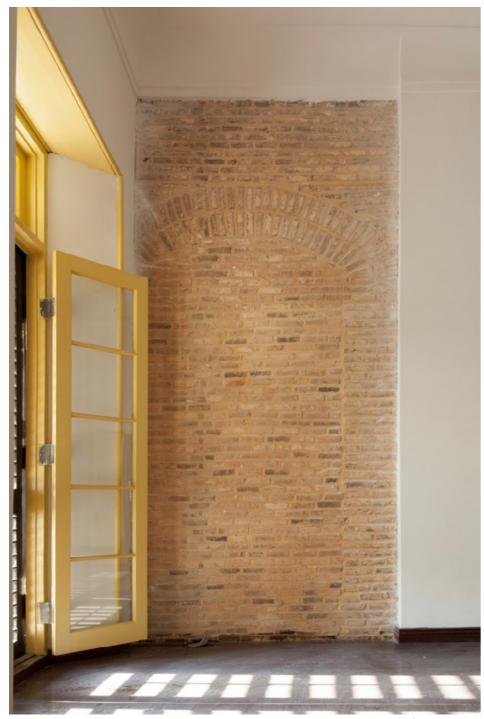
门券展示 ©CHCC

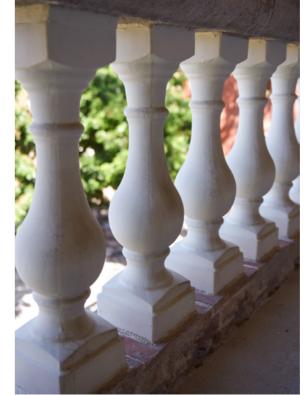
宝瓶栏杆完成效果 © 程固

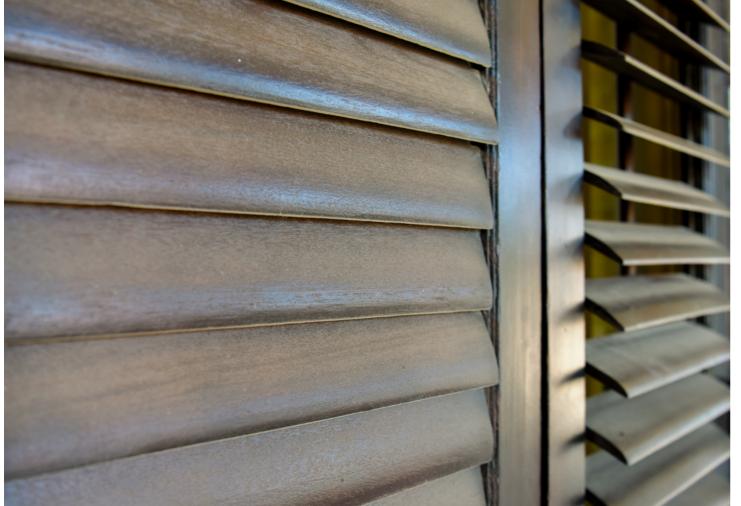
窗百叶完成效果 © 张光玮
